UNDERWATER BRIDGE INSPECTION REPORT

STRUCTURE NO. 3575

FORD PARKWAY

MISSISSIPPI RIVER

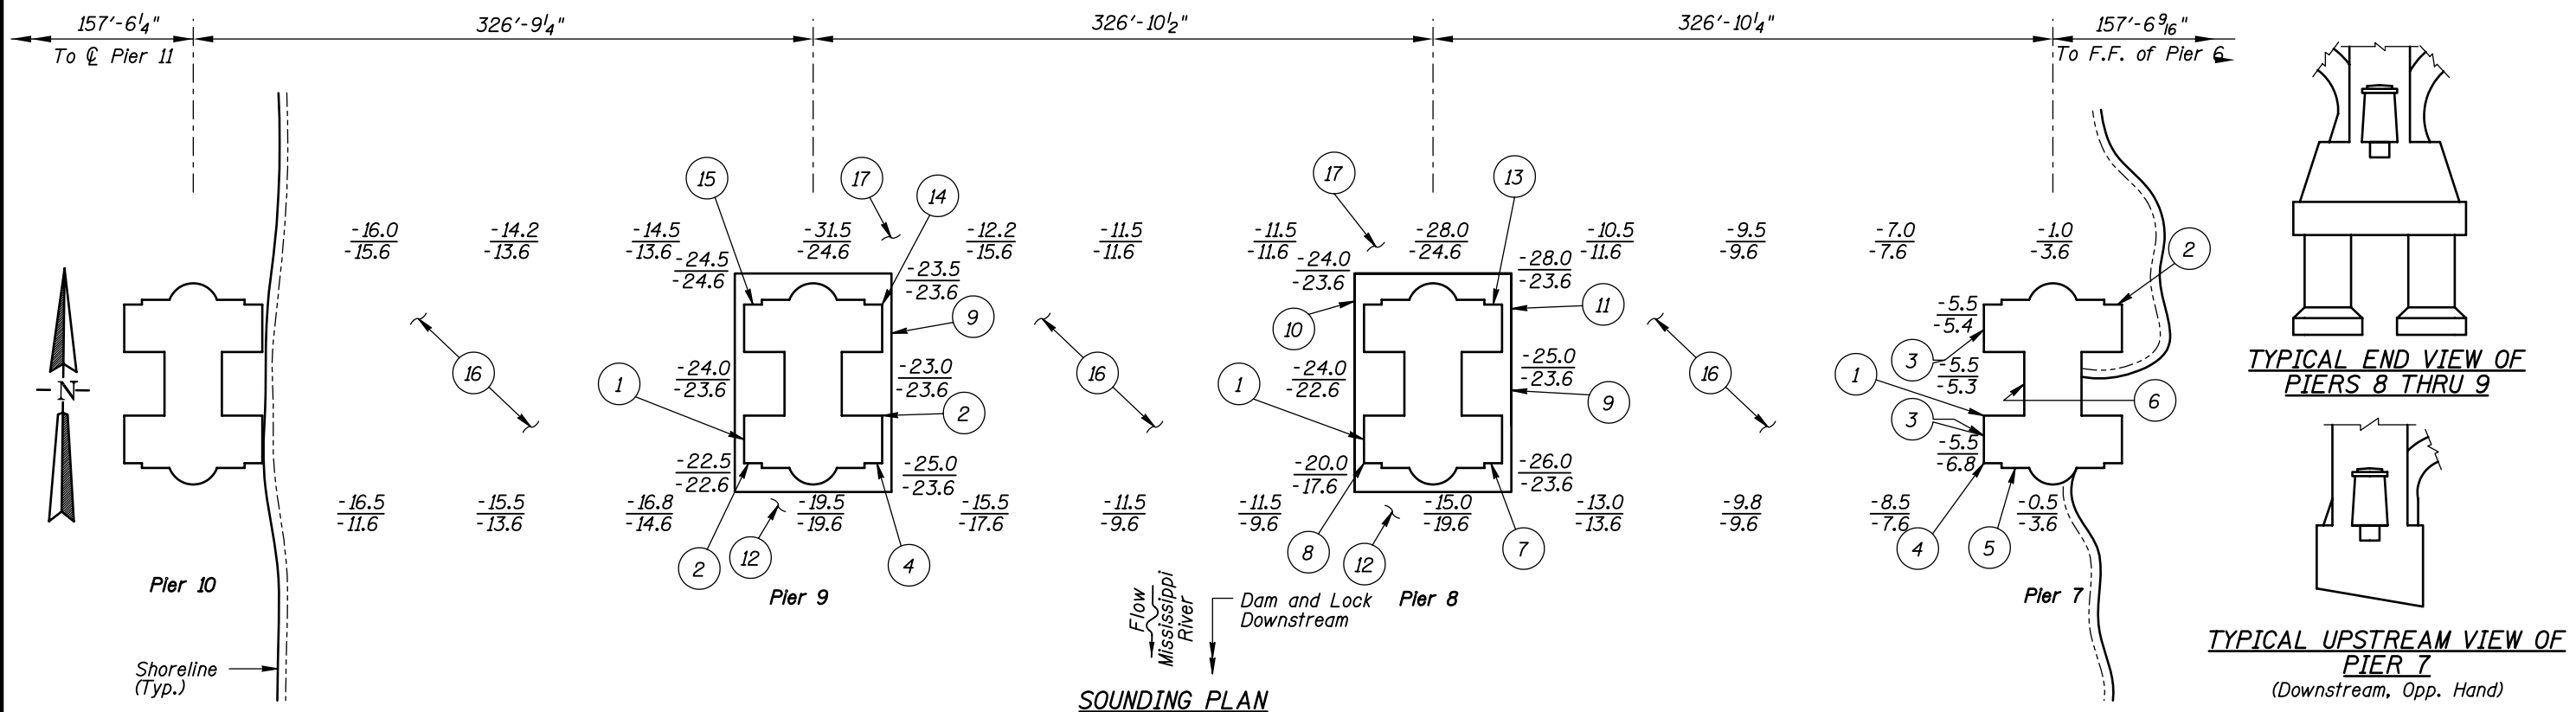
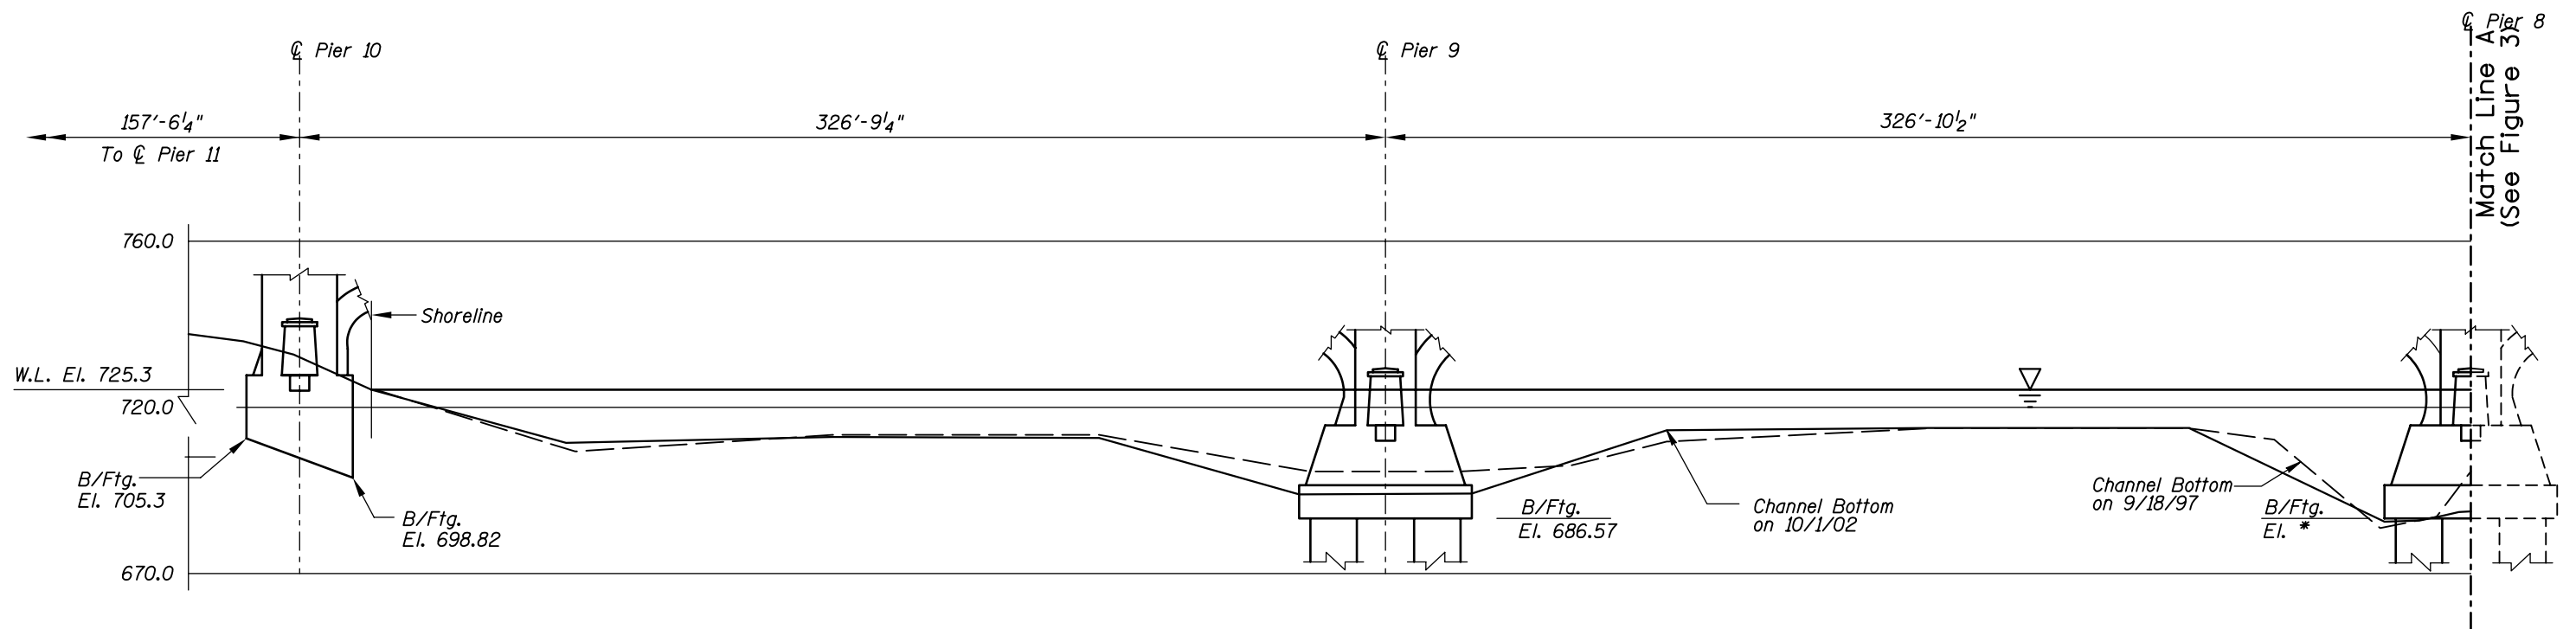
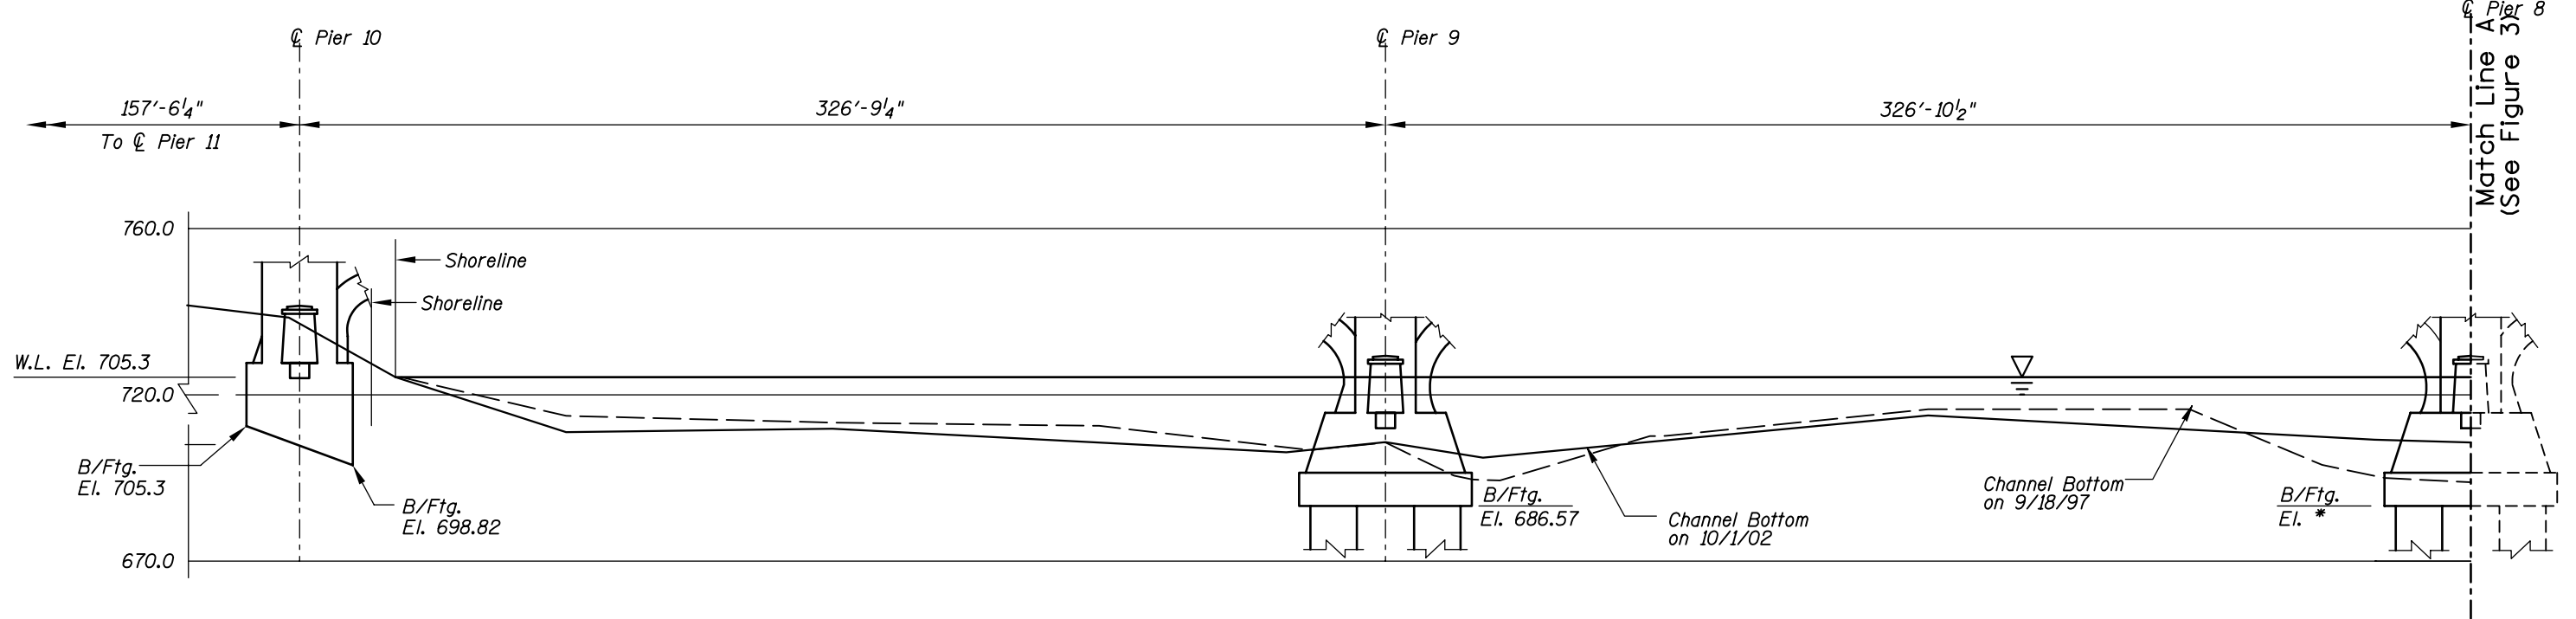
* The bottom of footing elevation noted on the Design Plans does not correspond to the soundings and/or undermining detected at the time of the underwater inspection.

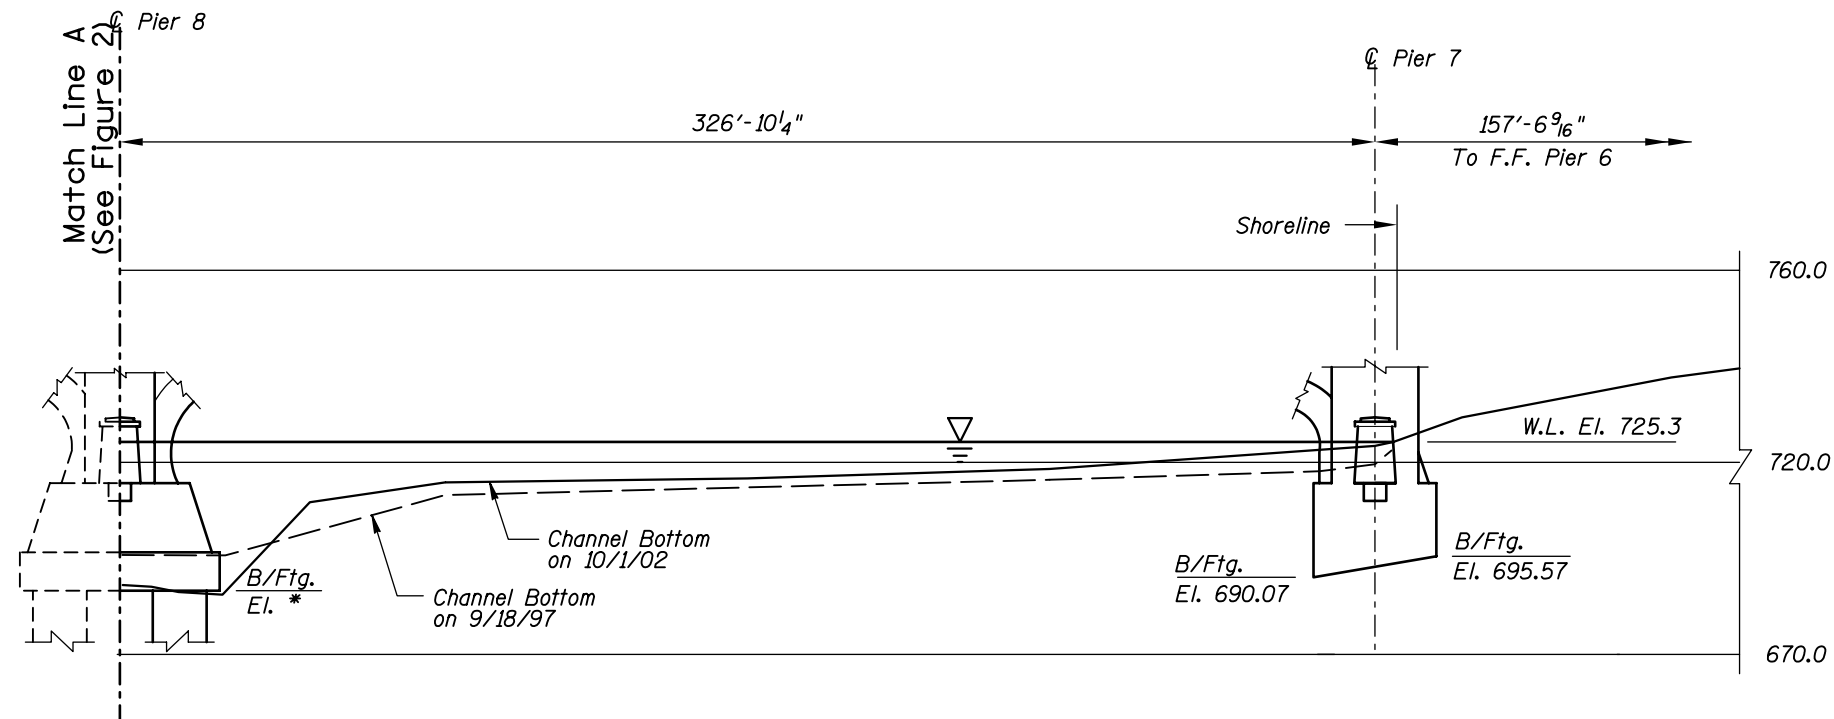
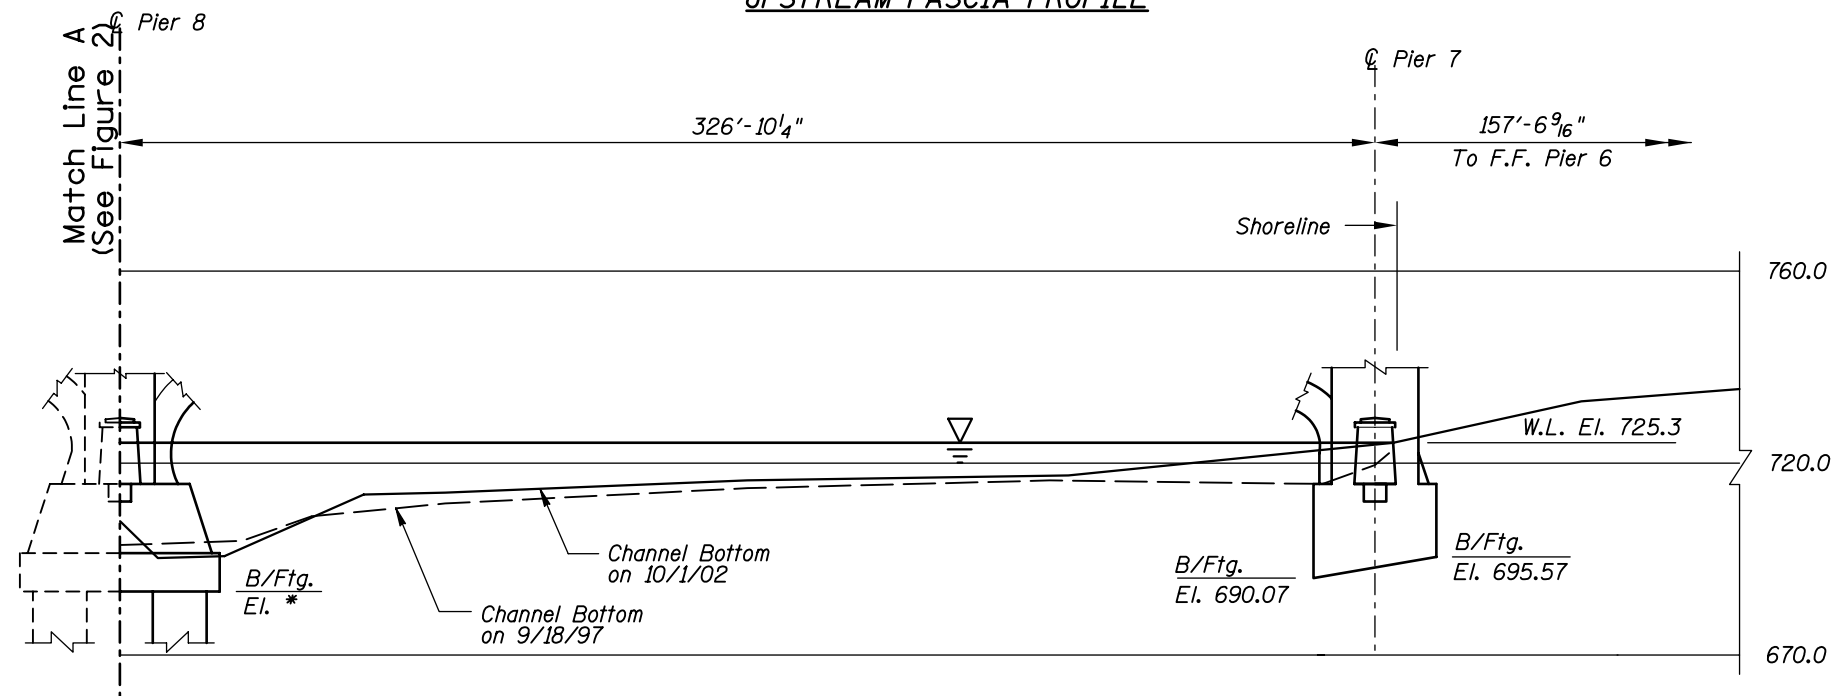
COLLINS ENGINEERS, INC. 300 W. WASHINGTON, STE. 600 CHICAGO, ILLINOIS 60606 (312) 704-9300	Date: OCT. 2002
Checked By: MDK		Scale: 1"=50'
Code: 35I20I22		Figure No.: 3

* The bottom of footing elevation noted on the Design Plans does not correspond to the soundings and/or undermining detected at the time of the underwater inspection.

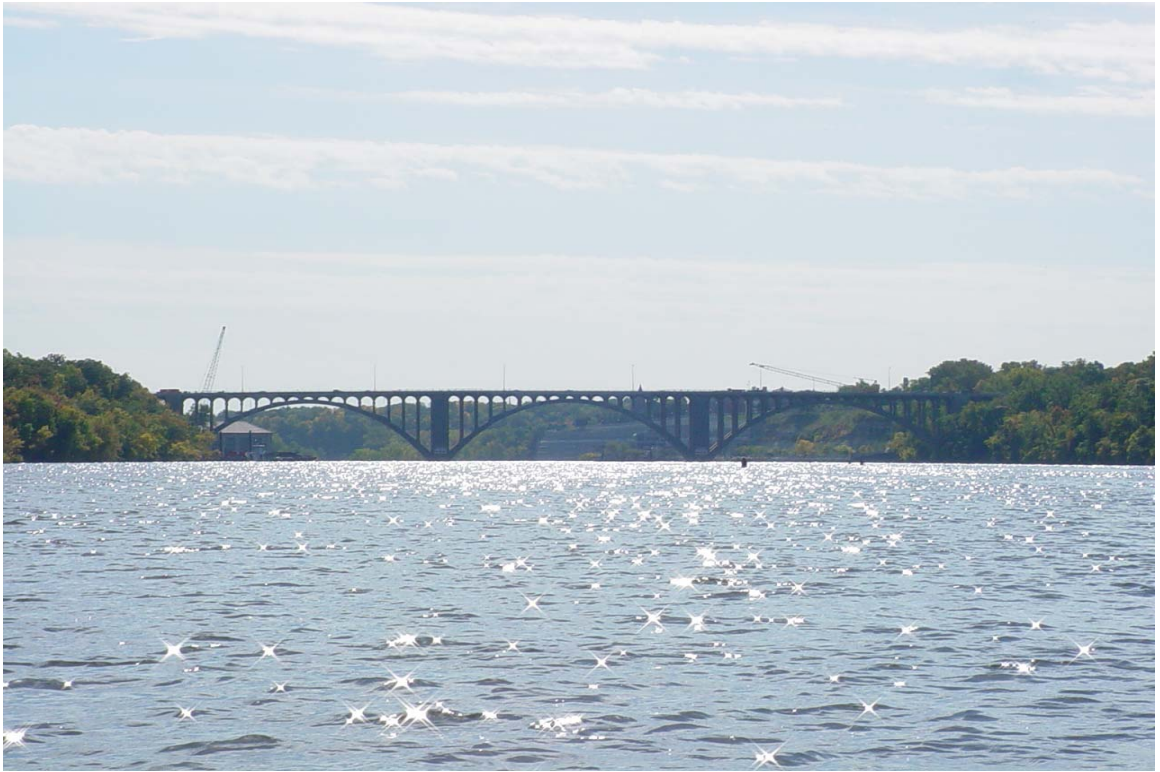
Photograph 1. Overall View of Bridge, Looking South.

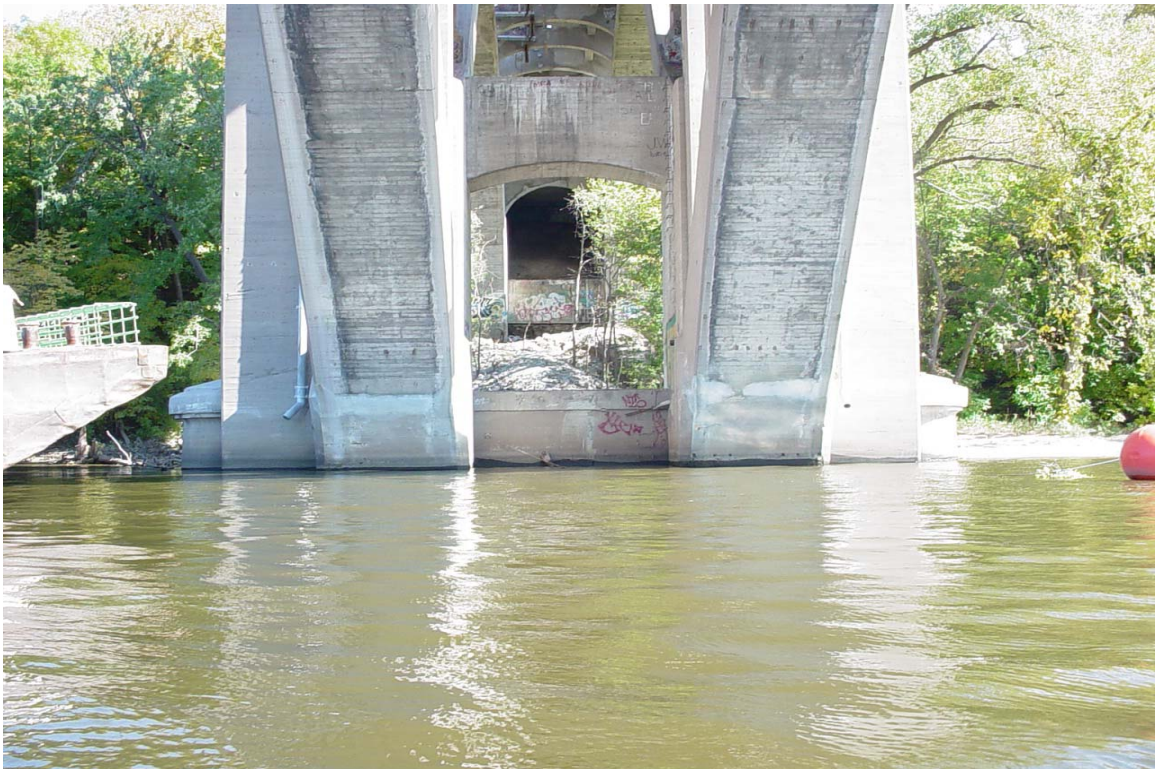
Photograph 2. View of Pier 7, Looking East.

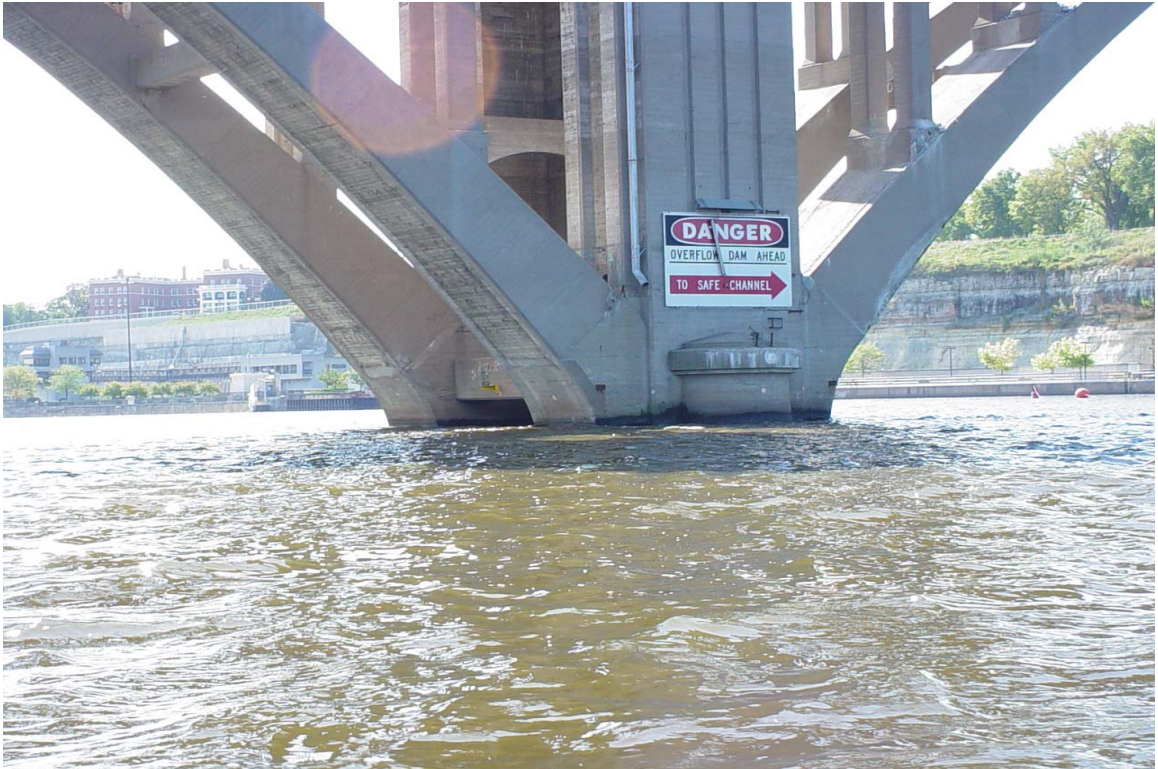
- (D) Undermining of the footing was observed at the northwest and northeast corners of Pier 8, with cavities that were 10 feet long by 1.5 feet high with more than 3 feet of horizontal penetration under the footing and 6 feet long by 1 foot high with up to 3 feet of horizontal penetration, respectively.

Photograph 3. View of Pier 8, Looking Southwest.

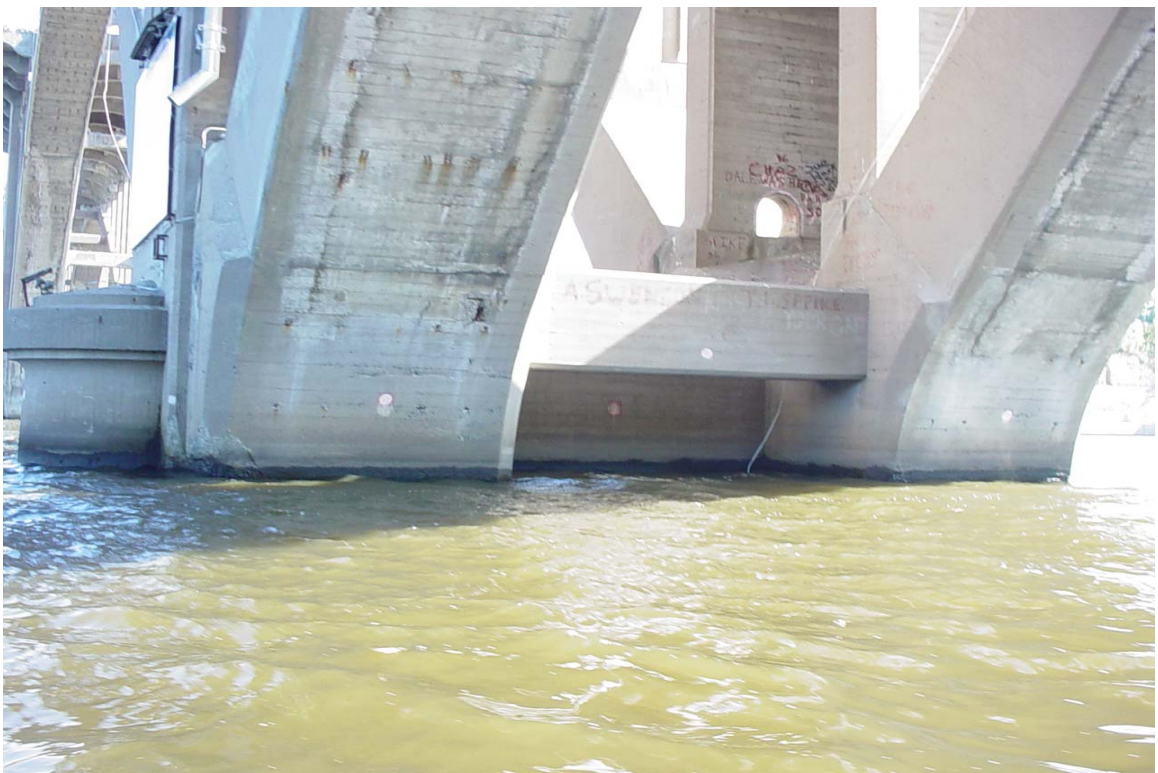
Photograph 4. View of Pier 9, Looking Southeast.
